Metallurgical Investigation and Analysis of Bevel Gear Failure

Vaibhav Gupta M.Tech student Dept. of Mechanical Engg. NIT, Kurukshetra	Dr. Surjit Angra Professor Dept. of Mechanical Engg. NIT, Kurukshetra	V.K. Mittal Professor Dept. of Mechanical Engg. NIT, Kurukshetra
---	---	--

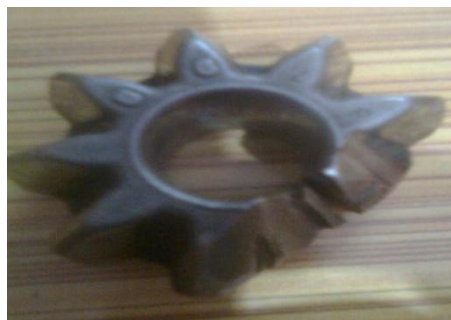
The failed bevel gear of TATA INDICA is shown in Fig. It is found that the fracture had taken place on the surface and side surface of a bevel gear.

Figure- fractured bevel gear

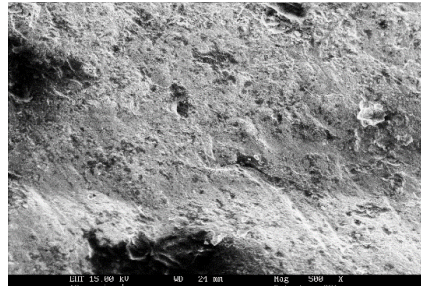
Figure- Image was taken at an manufacturing range of 2500X

It is showing casting defects i.e. gas porosity, dendrite shrinkage and accumulated inclusion, together with initiated crack. The characteristics of this shows that fracture is a brittle fracture-granular fracture (also cleavage fracture).

The main reason for the failure is casting defect, inclusion and crack propagation which decreased the lifecycle of bevel gear. Provision should be done for the removal of inclusion and shrinkage, avoidance of hard particle to enter. Some unwanted impurities have been also detected which allow cracks to pass straight through. Failure of bevel gear may lead to failure of other components and can cause harm while in use. Finally bevel gear should be designed with high reliability. It must be capable for sustaining heavy stresses caused by thrust and pull of the bevel gear. So the homogeneous and continuous structure is a desired factor for bevel gear.

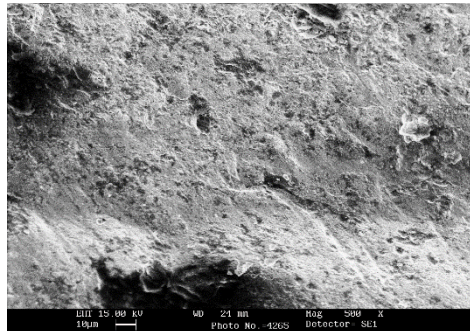
During casting some unwanted material had been also present Due to these impurities the bevel gear could not be able to withstand fatigue stresses and failure has taken place.

Figure- This image was take at a magnification of 500X from two different surfaces were seen.

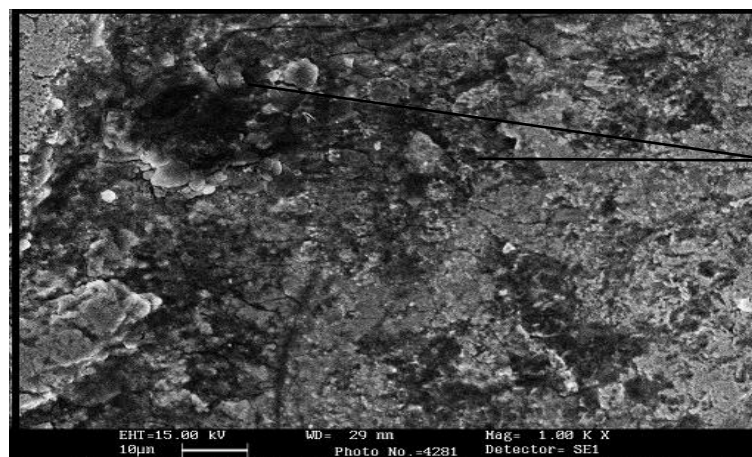
Brittle Fracture

From various literature review it was seen that the fracture which usually occurs in bevel gear is the brittle fracture and in this case we also get an image at a magnification factor of 1000X. We get that fracture was a brittle fracture. As the loads come on the bevel gear are varying in nature these are heavy shear and bending forces .So the failure occurs in bevel gear is the fatigue failure or sudden failure.

Figure A perfect brittle fracture surface could be seen at 1.00 KX

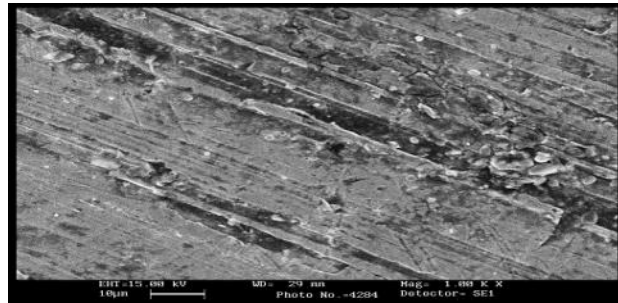
Figure The image was taken at a magnification of 1000X. to see the impure surface. White like crystals like material is impurity
