Analysis of Piston Pin Failure and Metallurgical Investigation

II. ANALYSIS

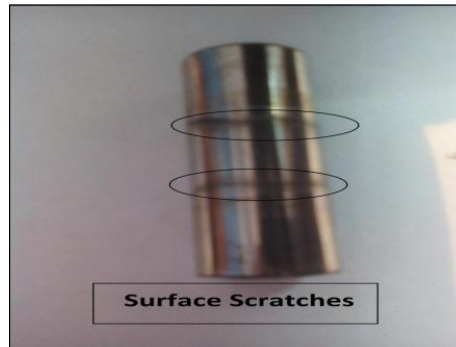
The failed piston pin of Hyundai is shown in Fig. It is found that the fracture had taken place on the inner surface and side surface of a piston pin.

Figure- Surface scratches

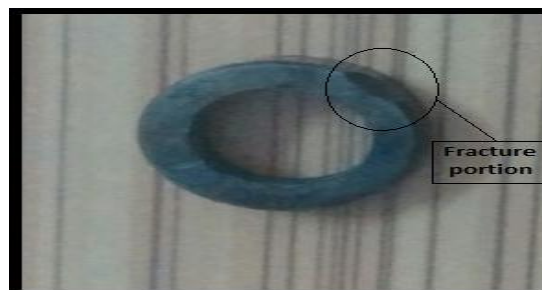
Figure- Part of piston pin to undergo SEM

A failed piece of piston pin has been from the workshop and a piece has been taken out from the failed area of piston pin. After that this piece has been converted into specimen for undergoing SEM in the dimension of 14mm x 7mm. The operating environment of a standard scanning electron microscope dictates that specialist preparation techniques are used. Basically a specimen is chemically fixed, dehydrated through an acetone or ethanol series and after that dried at the critical point - a method used to minimize specimen distortion due to drying tensions.

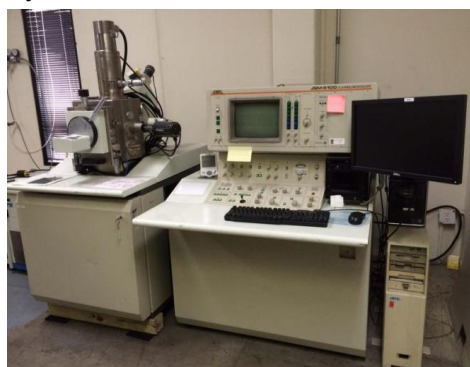
Figure- JEOL SEM Model JSM6100

The fracture analysis of the piston pin was done by visual inspection and SEM (Scanning Electron Microscope). The SEM observation has been taken using JEOL SEM Model JSM6100 Scanning Electron Microscope.
